**PROJECT:** Rehabilitation of concrete septic tank

**OWNER:** Burning Tree Country Club

**DATE:** February 16, 2018

## When it comes to rehabilitation, CLADLINER is a hole in one

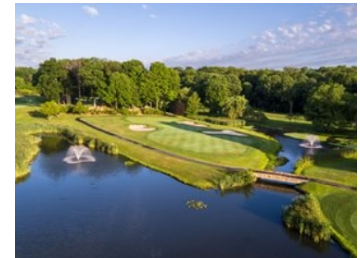
Cutting up the greens of a golf course to replace a deteriorating septic tank is hardly an ideal situation for a private country club. But when one of the concrete septic tanks at Burning Tree Country Club in Greenwich, CT, became severely deteriorated, replacement became a real option, although not a desirable one. That is, until [Savy & Sons](#) and Marilyn Baron of CLADLINER presented an effective and much more affordable solution rehabilitating the tank using CLADLINER products rather than replacing it.

Savy & Sons is a family-owned and operated, full-service contracting, masonry, and restoration firm in Connecticut that has been a coating expert in the rehabilitation industry for over 50 years. When presented with the deteriorating septic tank, they suggested using CLADLINER to restore instead of replace the structure.

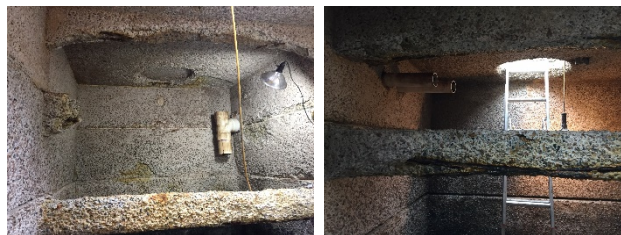
CLADLINER products, designed specifically for rehabilitating water/waste water structures, combine the simplicity of a cementitious liner with the performance of a high-build epoxy liner. CLADLINER offers high chemical resistance and antimicrobial performance in a single system and addresses corrosion caused by acid attack, hydrogen sulfide, and inflow and infiltration (I&I), while also protecting concrete.

The surface preparation of the structure was like that of other coatings. A high-pressure blast with an oscillating nozzle removed any loose debris from the substrate before using a repair mortar to patch the most severely deteriorated areas.

CLADLINER was then mixed in a 1:1 ratio and applied with an air gun in two half-inch coats to this 9' x 16' x 10.6' structure. The entire project from start to finish was completed over a three-day period using three applicators.

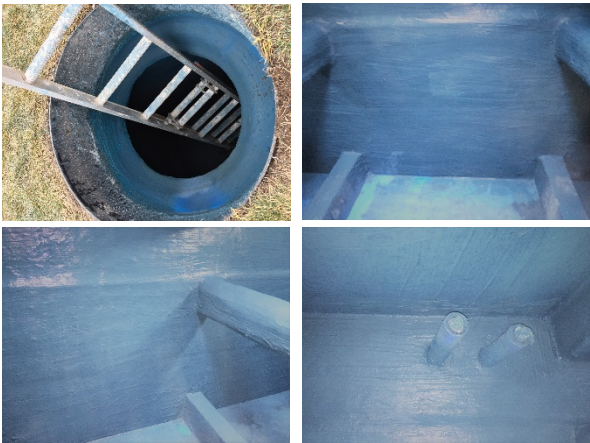
Replacing this septic tank would have cost the owners at Burning Tree Country Club at least three times more than it cost to rehabilitate it, not to mention the closure and costly repair of the green. Using CLADLINER not only made for a quicker project repair but also a more effective, long-lasting solution.
