What We Do WATERPROOFING SOLUTIONS.

EXTERNAL ELEVATOR SHAFT.

West Hartford, Connecticut | August, 2018

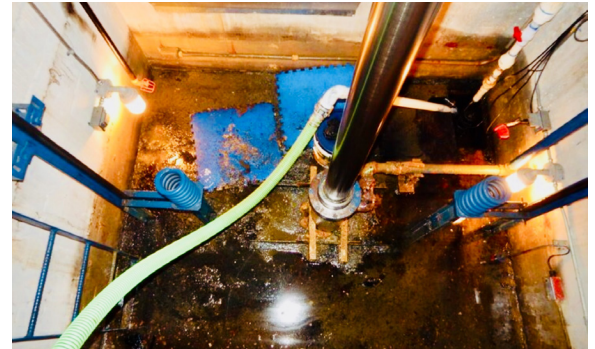
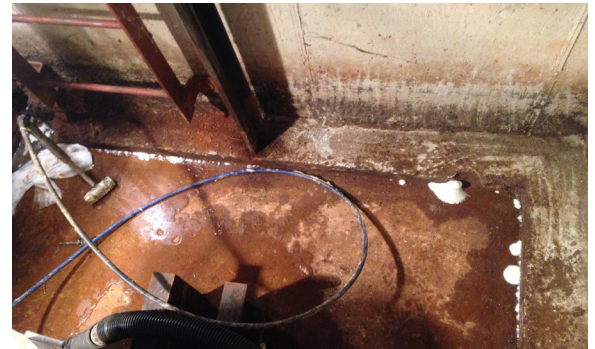
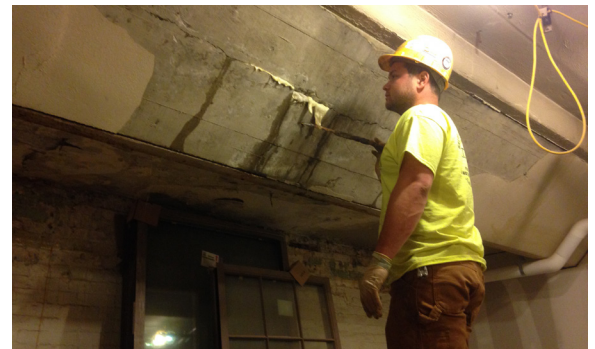
All previous attempts to waterproof the underground elevator pit had failed. Water was still leaking into the pit - and pooling at the bottom - causing rust on the pipes within the hydraulic system. Left unaddressed, the hydraulic system would need repair or replacement, and would lead to the elevator being out of service for an extended period of time, as well as be a significant expense that the building owner would like to avoid.

As with all elevator shaft repairs, Otis Elevator referred the building owner to Savy & Sons to explore a new waterproofing option. After the initial consult and examination of the underground elevator pit, Savy & Sons cleaned the pit of the residual water and oil, and was then able to pinpoint the water infiltration areas, drill and inject each of them with a polyurethane hydro active grout to permanently seal the leaks, keeping the pit dry. The project took two days, minimizing the downtime for the elevator, and the overall project costs, saving the client money.

The rainy summer weather following the repair tested the Savy & Sons solution, and the building facilities manager reports that the pit remained dry.
