## CHARLES RIVER DAM PUMP REHABILITATION. NASSAU, BAHAMAS| August, 2023

On the sunny island of New Providence, Bahamas, a wet well for the local water company was experiencing intense infiltration near the water well base due to malfunctioning pumps from the pump station. After injection grouting, infiltration was stopped, and thousands of dollars were saved.

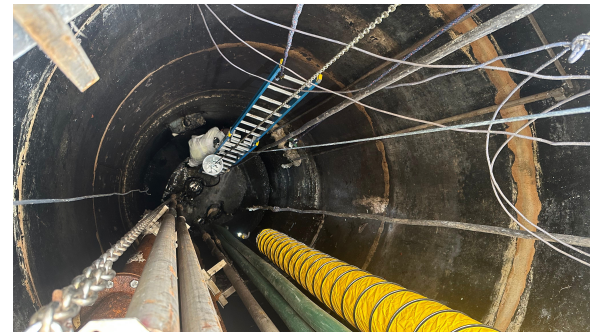
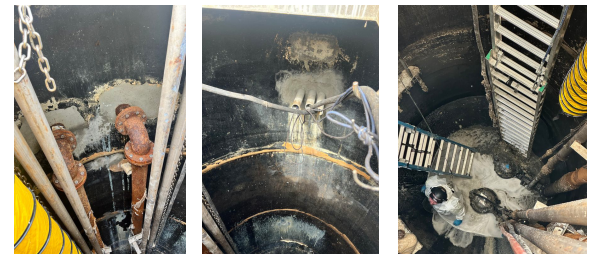
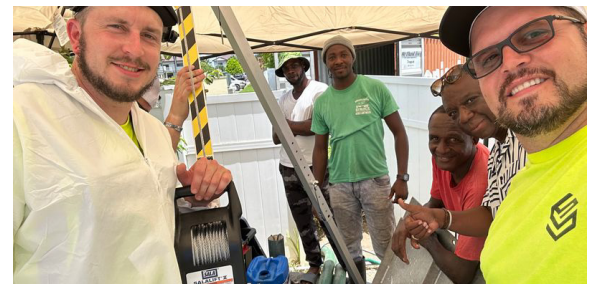
The precast wet well is approximately 10' ID by 40' deep and is surrounded by a high water table. Shortly after installation, groundwater infiltration began entering the structure through the lower tiered riser joints. Over the span of a couple years, the defect continued to increase in size causing a rise in infiltration volume – up to 120 gallons of water per minute. Due to the size of the structure and high water table, complete replacement or any excavation was going to be extremely expensive, time and labor consuming, and very invasive to the community. NPWDCo and BHM Group tried to form, pour, and set a hydraulic cement block over one of the leaks, but shortly after it also sprung a leak. The team researched technologies and discovered some solutions, but they had trouble finding someone local to complete the work. In their research they came across Connecticut-based Savy & Sons – a full-service contractor specializing in Water & Wastewater Rehabilitation, Coatings & Linings, and Infrastructure Restoration. The Savy Team has over 100 years of combined experience in different aspects of waterproofing and restoration and was just the team for the job. After initial conversations about the wet well, the Savy Team flew to Nassau to assess the problem and quickly generated a game plan to ship equipment, materials, and crews down to the island to begin working on eliminating the groundwater infiltration. Upon mobilizing and entering the wet well, the Savy Team found that four pumps were being used: two pumps from pump trucks, and two from within the wet well – one of which was malfunctioning. The water infiltration was entering the wet well so fast that the three usable pumps could not keep up with dewatering. Once the fourth pump was fixed, the Savy Team was able to pump out 99% of the water infiltration and clean the structure to begin rehabilitation.

Due to the water infiltration rate being so high, AV-219 Fibrotite – also known as Oakum – was used to pack the defect of the heaviest gusher that was spraying 'water like a fire hose'. This allowed the infiltration to slow enough to allow for a safe work zone.

The Savy Team then proceeded to injection grout at all riser joints, pipe penetrations, and any other weak points to fully seal the structure. The job was comprised of three, twelve-hour days in the middle of August where temperatures were above 110 Fahrenheit. Extra safety precautions were taken due to the heat, especially inside the wet well. The Savy Team injected the wet well with around 30-gallons of AV-275. Due to its low viscosity and expansive nature, AV-275 was able to permeate the soils around the structure and fill any voids creating a waterproof barrier around the wet well.
