AEROSPACE PIPING RESTORED WITH COMPOSITE WRAP

Hartford County, CT | April 2024

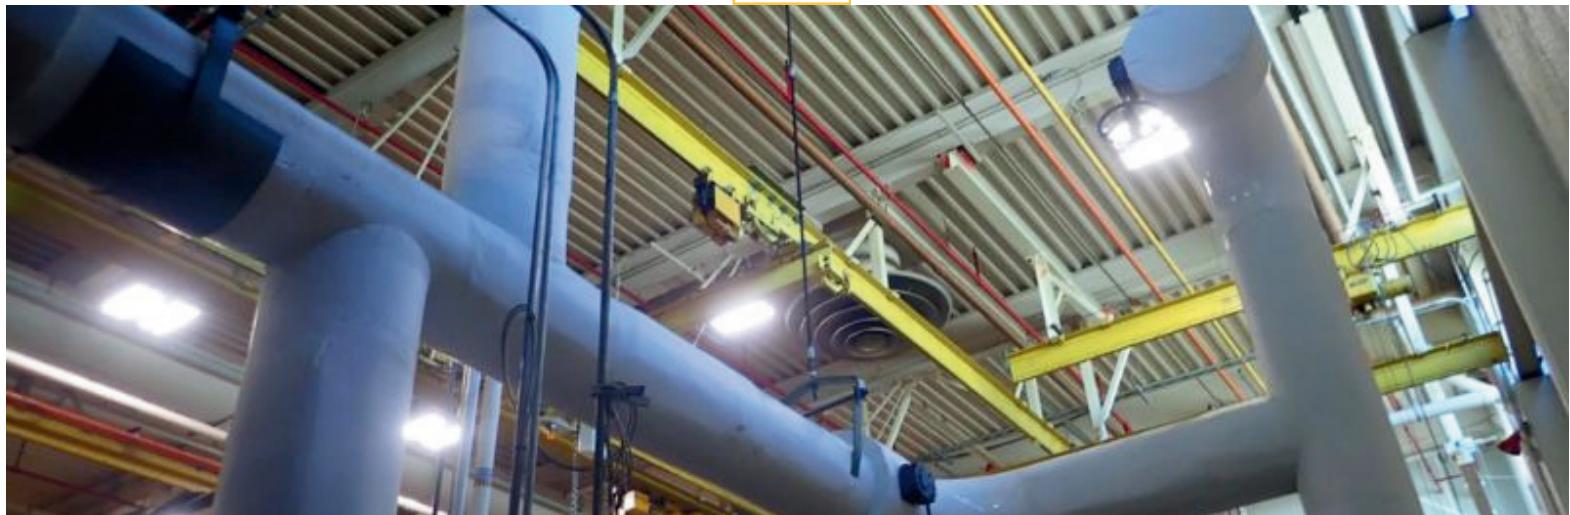
A global leader in aerospace manufacturing, faced a critical challenge with their pressurized 14" and 22" carbon steel intake/supply lines. These vital pipelines, crucial to their operations, experienced localized interior deterioration, resulting in periodic blow-outs. The pipes were so compromised that they couldn't withstand a pressure of 60 PSI, posing a serious risk to operations. The weakened state of the pipes threatened the company's efficiency and safety, necessitating an immediate and effective solution. To prevent further failures and maintain system integrity until a permanent solution could be devised in 5-10 years, this organization sought an emergency preventative maintenance service. They chose the Belzona SuperWrap II carbon fiber system to provide a reliable and effective interim solution.

To address the issue, we wrapped approximately 175 linear feet of the 14" and 22" pipes with the Belzona SuperWrap II system. The project took six weeks and required meticulous planning and execution to meet the highest safety and quality standards.

Next, the team removed and disposed of all pipe insulation, prepping the exterior of the pipes using bristle blasters while the pipes remained in service. This preparation was critical to ensure a clean and dust-free surface for the wrap application. Following manufacturer recommendations, the Belzona SuperWrap II system was then meticulously applied. The process required careful attention to detail, especially given the challenging conditions. The pipes were 8 to 14 feet off the ground and surrounded by various other utilities, making access and scaffolding the most significant hurdles.

One of the unique challenges of this project was maintaining the correct environmental parameters. The pipes, carrying 55°F water, were prone to sweating and condensation. To mitigate this, the team employed heating, cooling, and dehumidification systems to ensure the pipes remained dry and at the optimal temperature for the application of the wrap.

The innovative Belzona SuperWrap II, an engineered design, was used to fully restore the strength of the old deteriorated pipes, ensuring they could sustain the required 60 PSI pressure. This technique allowed the business to remain in full operation while our work was being performed, allowing for no downtime in their daily work. We are proud of our team's expertise and dedication in restoring the operational integrity of the aerospace company's piping system. This successful project not only resolved their immediate concerns but also reinforced our commitment to providing top-tier industrial repair solutions.
