## SEAWALL REPAIR & SOIL STABILIZATION FOR A COMMERCIAL PROPERTY

Stratford, CT | September 2022

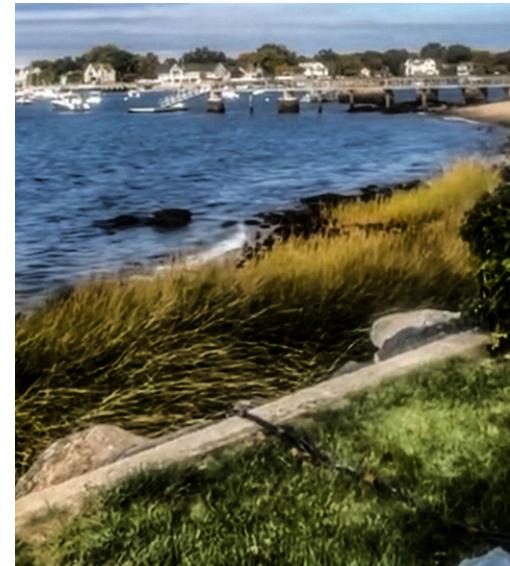
**Erosion from Storm Surge:** Water surging over the wall consistently washed away soil and turf. **Unstable Soil Conditions:** Initial testing revealed spongy, loose soil behind the seawall that could not provide adequate support. **Irrigation System Navigation:** The property's lawn featured a complex irrigation system that needed to be carefully mapped and avoided during soil injections. **Large Landscape Features:** Surrounding boulders and established landscaping required precise drilling and injection placement to prevent damage.

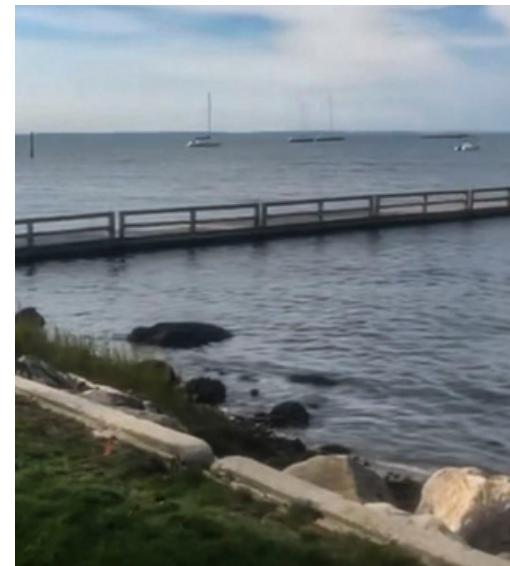
**1. Stem Application & Grid Drilling** – We drilled holes in a strategic grid pattern behind the seawall. Acrylate material was injected directly into the soil to bind particles together, preventing further erosion and water washout.

**2. On-Site Soil Monitoring** – All injections were performed and monitored in real time. Our team was able to adjust as needed, ensuring complete coverage without the need for return visits.

**3. Landscape & Utility Protection** – The irrigation system was fully mapped before drilling to avoid damage. Extra care was taken around large stones and landscaped features to preserve the property's aesthetics.
