Rehabilitation of a Deteriorated Sanitary Manhole Using Spray-Applied Protection

This case study highlights the rehabilitation of a sanitary manhole located in a residential neighborhood in Connecticut. The structure exhibited extensive concrete deterioration and infiltration issues and required a comprehensive repair approach to extend its service life and restore performance.

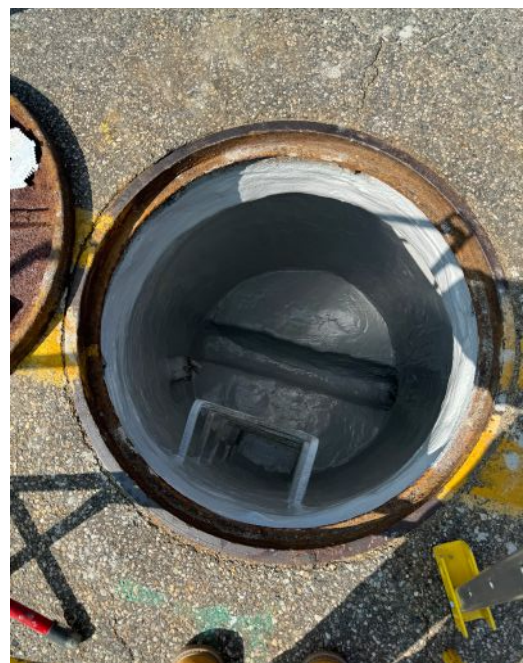
The primary challenge associated with the project was the extent of concrete degradation within the manhole. Spalling concrete ranging from approximately $\frac{1}{2}$ to $\frac{3}{4}$ in. deep was observed on interior wall surfaces, requiring thorough removal of unsound material prior to rehabilitation. Deterioration was also present at the pipe table, where loose brick and compromised mortar joints reduced the structural integrity of the bench area.

A significant void space was identified behind a 4-in. force main pipe penetration, estimated at approximately 18 in. by 18 in. This void posed a risk of continued infiltration and further structural damage if not properly addressed. In addition, an existing coupler attached to the end of a pipe was

To address the large void behind the 4-in. force main penetration, a void-filling operation was performed using MortarTec Hydrxx-1. The material was injected to fill the estimated 18-in. by 18-in. void, stabilizing the surrounding area and preventing water migration behind the manhole wall.

The existing coupler attached to the end of the pipe was removed in accordance with the owner's request, as the drop connection was not scheduled to be reinstalled. This allowed the penetration area to be properly prepared and incorporated into the rehabilitation system.

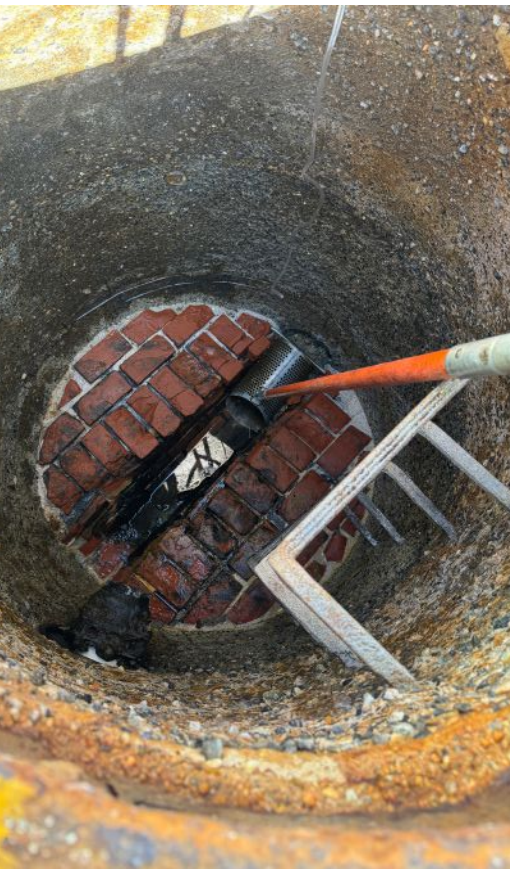
Rehabilitation activities began with comprehensive surface preparation to remove deteriorated material and contaminants from the manhole interior. High-pressure water blasting was used to clean the walls, bench, and flow line, exposing sound substrate and identifying areas requiring repair. All debris

Once all repairs and void filling were completed, the manhole interior was rehabilitated using a multi-step resurfacing and lining system. First, the structure was resurfaced using Epoxytec MortarTec Silicate, an industrial-grade resurfacing material composed of Portland cement, graded silica sand, fibers, and microsilica. The material was applied at an approximate thickness of 1 in. to restore the interior surfaces and address areas of concrete deterioration.

Following resurfacing, a spray-applied CPP Sprayliner was installed as the final protective lining. The material is an ultra-high-build, structural-grade, micro-fiber-reinforced polymer (FRP) modified polyamide epoxy, applied at a thickness of approximately 200 mils. The lining formed a continuous, protective barrier over the rehabilitated surfaces, enhancing resistance to moisture intrusion and long-term deterioration. Installation was completed in accordance with manufac-
