PIPE LINING SERVICES.

REPAIR VS. REPLACE PIPE LINING.

Connecticut | November, 2019

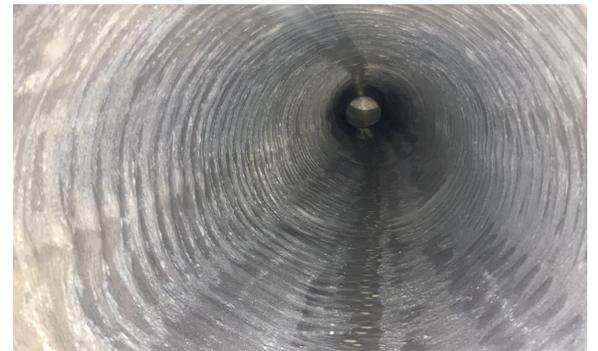
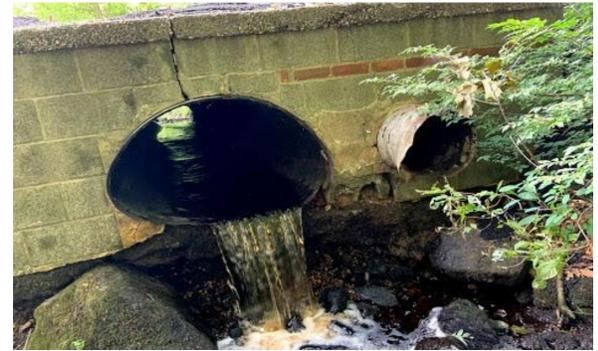
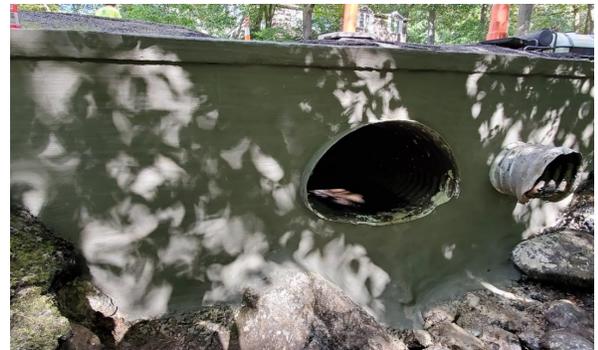
A town in Connecticut had a drain culvert with two steel corrugated pipes that were deteriorating, along with the concrete headwalls on either side of the road. One horseshoe-shaped steel corrugated pipe 42" in diameter and the other 15"-diameter round pipe were rotting out and the concrete bulkhead block walls on each side were severely deteriorating. The town needed a solution that could hold up for years to come, was both efficient and cost-effective, and could be installed without shutting down and digging up the road. Savy & Sons proposed that Epoxytec CPP Sprayliner for the headwall repairs and horseshoe-shaped pipe and a Perma-liner Cured-in-place-pipe (CIPP) pipe lining system would be just the solution for the round pipe.

In order for Savy & Sons to perform this project, the river flow had to be bypass pumped and diverted across the roadway while the pipes were rehabbed and lined. Once the flow was diverted, Savy & Sons inspected the damaged pipes using a CCTV camera system to determine the extent of the repairs. After the inspection, we jetted and descaled the pipes to prep for the pipe liner systems to be installed. Once we installed both of the pipe lining systems we made all masonry repairs to the headwalls before finally installing the Epoxytec CPP Sprayliner system at 125 mils thick over the masonry to reinstate its structural integrity and protect against future deterioration.

These repairs came with a Savy standard 10-year warranty and an ASTM-rated minimum lifespan design of 50 years. The roadway never had to be shut down nor was any excavation needed. The entire project was executed in less than three days. The project showcased a phenomenal alternative solution of repair vs. replace.
